Subject: Exide Closure - **Notice of Violation Issued by DTSC and SCAQMD**

Incident Summary

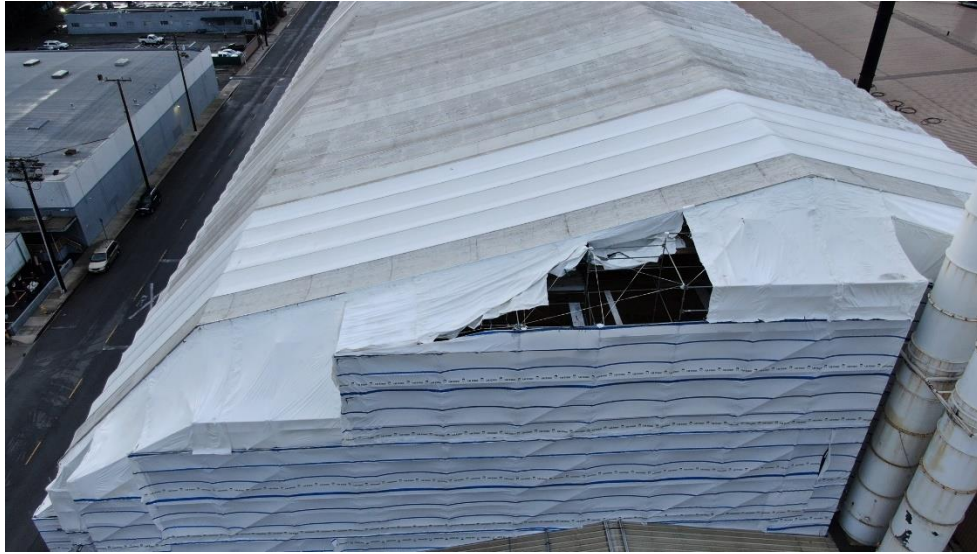
On December 26, 2019, the heavy plastic sheeting covering the full enclosure unit (FEU) ripped during a high wind event (see Figure 1). The incident did not result in exceedances of lead or arsenic air quality standards (see Figure 2), measured at the facility perimeter as specified in Exide's South Coast Air Quality Management District (SCAQMD) Title V permit or the DTSC approved-Closure Plan. However, DTSC is issuing a Notice of Violation to Exide today for not maintaining the required vacuum in a small portion of the full enclosure unit for approximately two hours (see Figure 3). Exide responded to the incident and completed repairs the same day (See Figure 4).

Figure 1: Aerial photo at approximately 7:00 a.m. December 26, 2019, showing the approximately 35-foot by 20-foot triangular FEU tear. The photo is facing south.

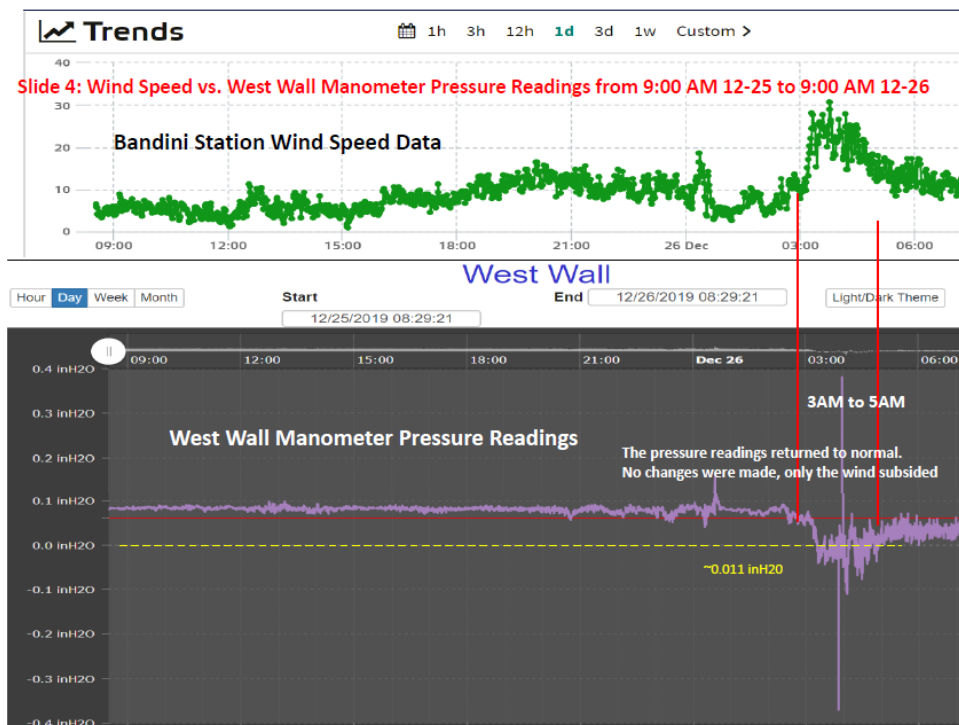
Figure 2: West Wall manometer pressure readings showing erratic negative pressure that corresponds with high winds between approximately 3:00 and 5:00 a.m.

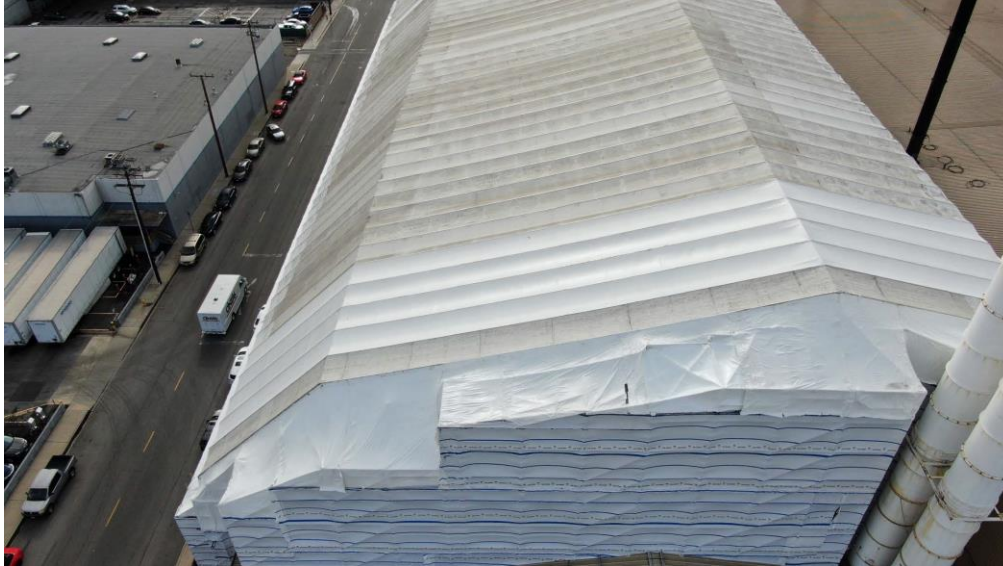
Figure 3: Aerial photo at approximately 12:30 p.m. December 26, 2019, showing the area of the FEU that was repaired. The photo is facing south.
